# CHURCH OF THE HOLY SEPULCHRE JERUSALEM

STRUCTURAL SURVEY  
FINAL REPORT

WILLIAM HARVEY

1935

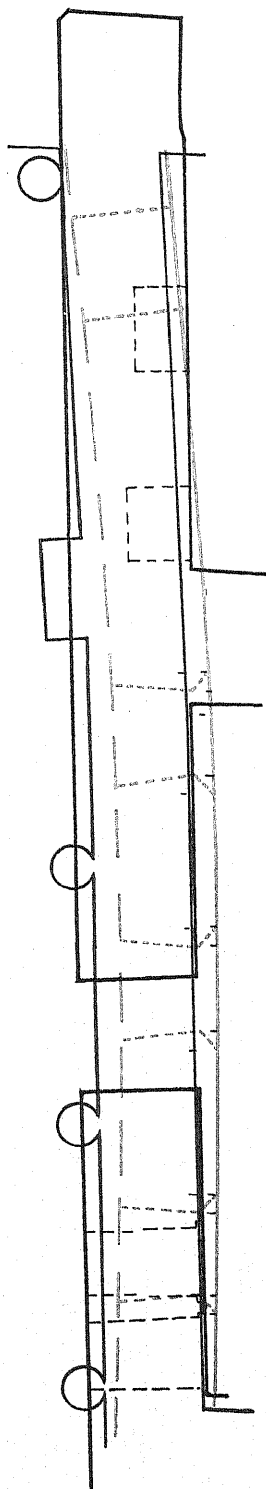
FIG. IV

the full thrust of the springing of the high vault (see Fig. 3) which it communicates to the North wall of the gallery, here an exterior wall of the Church. This wall contains the most dangerous evidence of movement in the building (see Fig. IV). For the lower half of its height, its outward inclination is approximately 1 in 60, but above this, for three metres below the sills of a series of windows lighting the upper gallery, it becomes rapidly sharper, reaching 1 in 20 and even 1 in 16. This is the more serious in that this upper walling contains work of several periods, ill bonded together, and much of the mortar has disappeared (see Fig. 7).

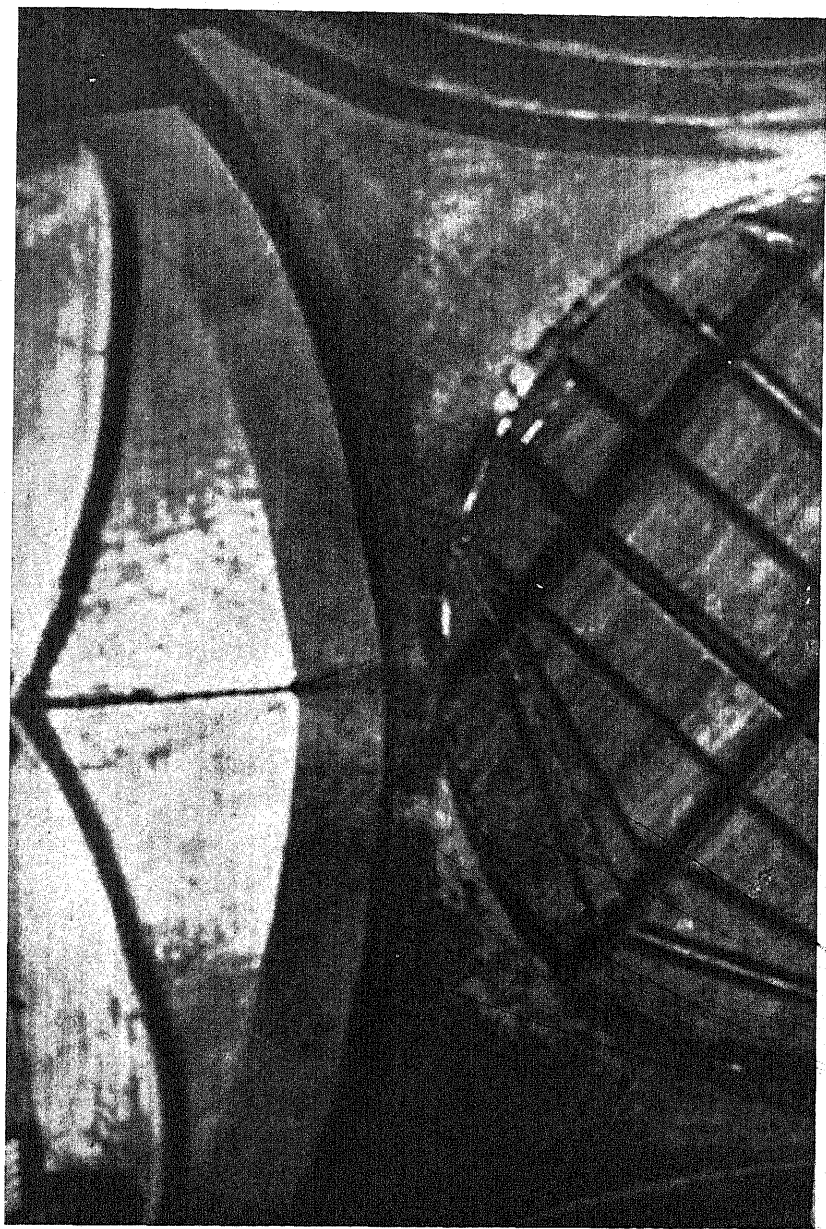
FIG. 1. EASTERN PENDENTIVES FROM BENEATH

The thrust is first communicated in a direction both downward and outward to the pendentives (see Figs. 1, 2, II, 24) supported on the four great arches of the crossing. It is to the position of the dome above the pendentives that the outward thrusts must be ascribed (see Fig. II).

The pendentives (see Figs. 1, 2, II, 24) receive the weight of the dome and transmit it to the four main piers below, but there is also considerable outward thrust, as the pendentives are not vertical, but inclined inwards to the bottom of the drum above. They were completely plastered over after the fire of 1808, and do not themselves show signs of great movement, except in the North-west pendentive, which is badly cracked. The piers below have decided leans outwards in the upper portions, and from this inclination the further parts of the building have received the damaging thrusts (see Additional Notes, p. 14).

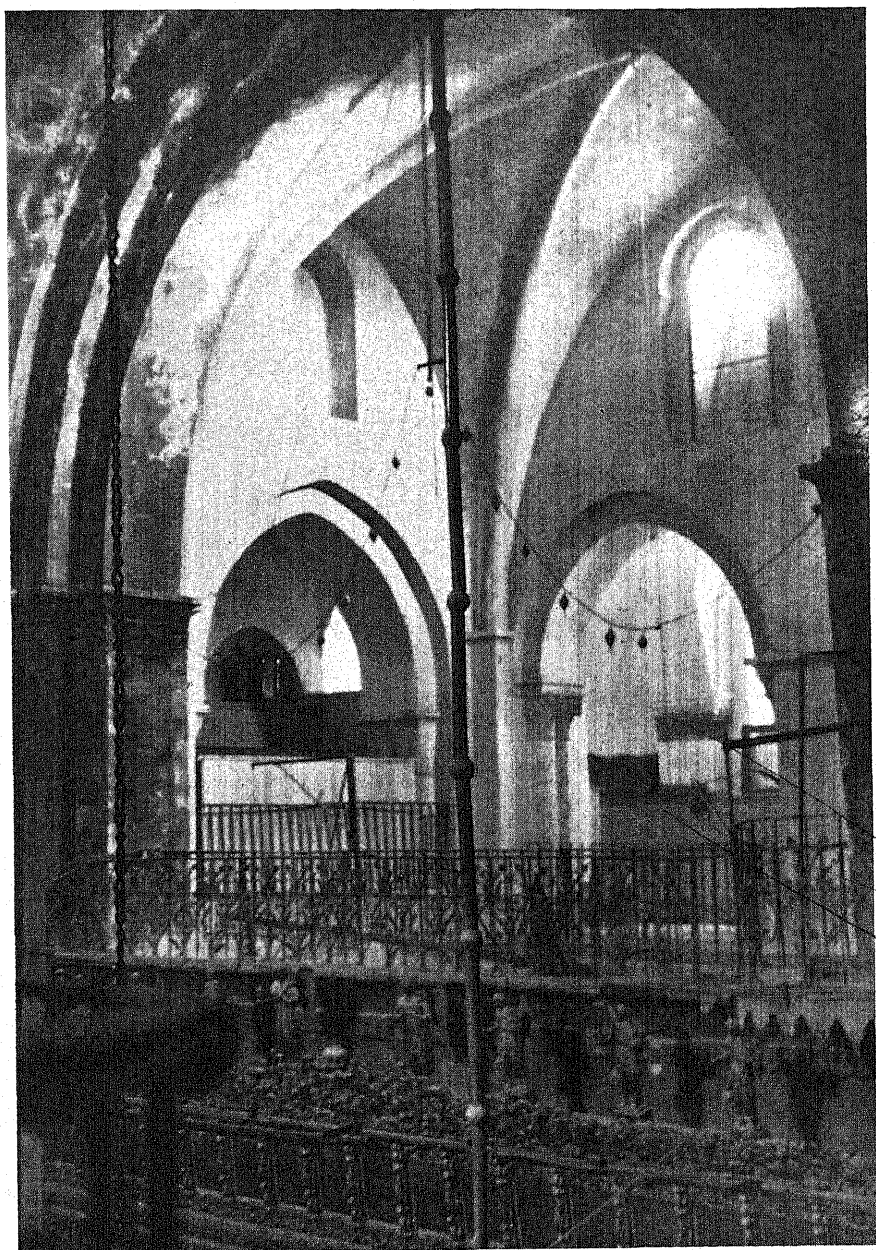
FIG. 3. NORTH TRANSEPT HIGH VAULT FROM S.E.

The North Transept proper consists of only one bay, with a vault above the main springing level of the great arches, and consequently occupying the same vertical space as the pendentives of the dome (see Figs. 3, I, 3). To the north of this bay is a gallery with two floors (see Fig. II, 9)—both originally of Byzantine construction; the lower vault (see Fig. 4) being below the Triforium arcades of the Transept proper. The upper vault (see Fig. 5) is above the Triforium, while leaving a clerestory lighting the high vault of the Transept above (see Fig. 6). This higher vault of the gallery is therefore in a position to receive

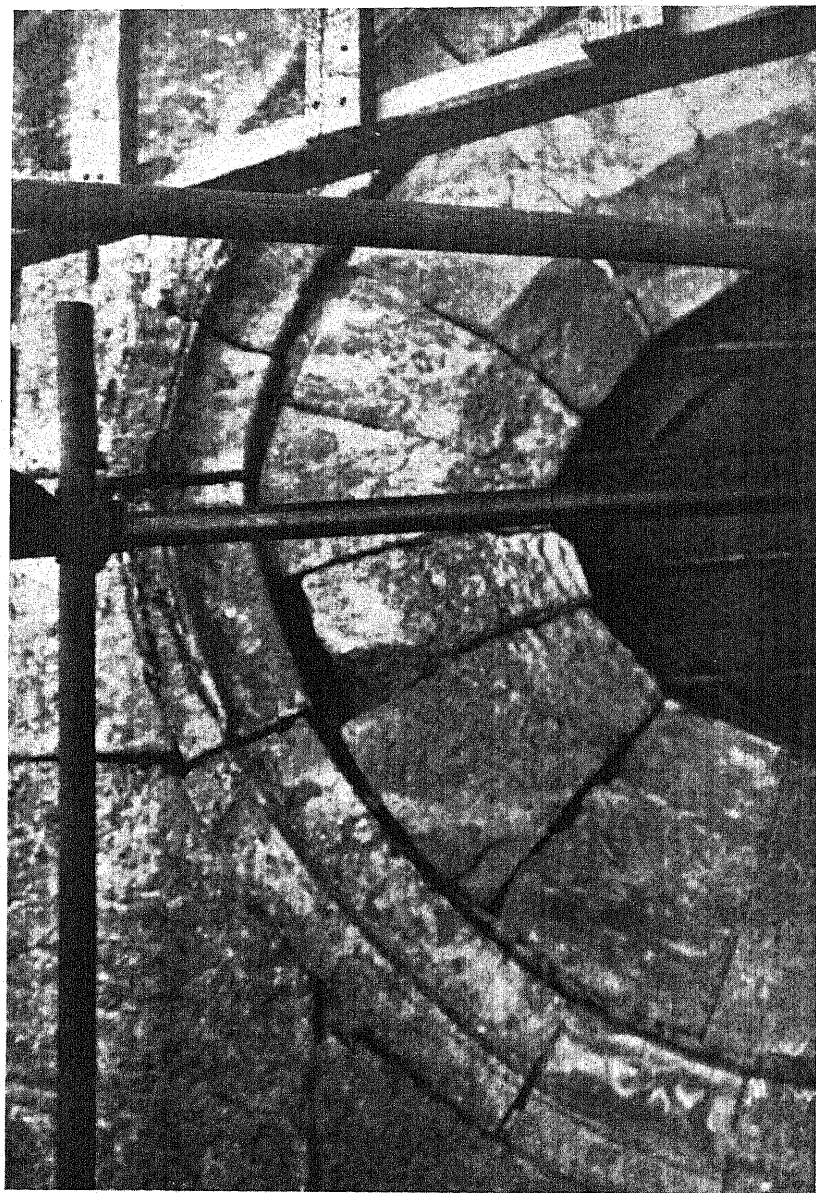
FIG. 8. A WINDOW-HEAD—NORTH WALL

Several instances occur of wide open joints penetrating through more than half the thickness of the wall, while the inner courses of voussoirs to the window arches have fallen downwards, leaving a wide space below the higher masonry (see Fig. 8). As the wall is restrained at each end by other buildings, leaving less than thirteen metres free to move outwards, such a grave inclination in the centre has resulted in great curvature of the wall-top (see Fig. 9) and this, together with the overhang and poor state of the mortar joints, may at any time allow the fall of some of the facing stones—should this occur any attempt to save the rest of the wall would be extremely dangerous, and collapse of the high vaults behind might easily follow.

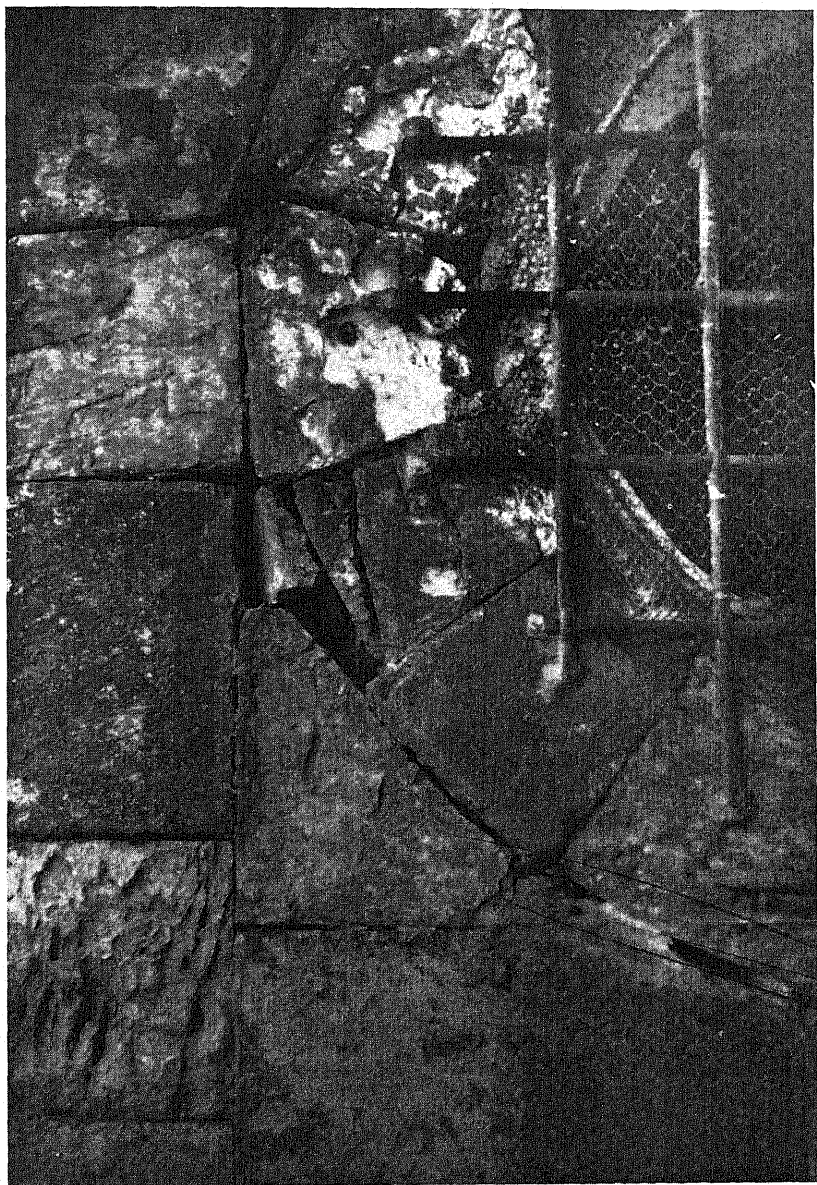
FIG. 13. NORTH TRANSEPT HIGH VAULT. E. WALL

The high vault itself (see Fig. 11) has also been plastered, but some two years ago a large stone fell from one of the main ribs, and the upper walls, where accessible from outside, are in an extremely poor condition (see Figs 12, 13, 14), many joints being completely denuded of mortar, and much of the masonry cracked and suffering from erosion, and to some extent from the effects of the fire of 1808.

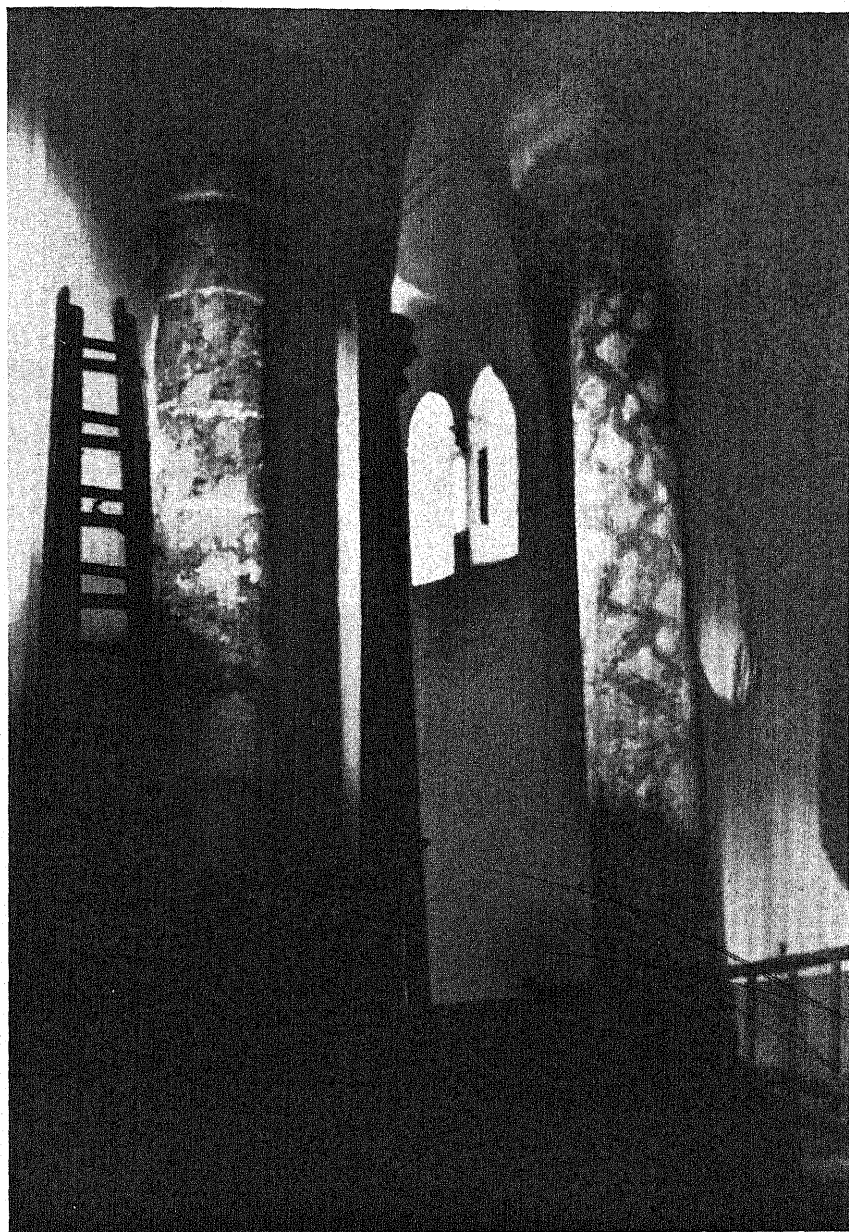
FIG. 15. E. COLUMN OF BYZANTINE ARCADE

The marble columns of the Byzantine arcade (see Fig. 15) are seriously cracked as a result of the thrusts, and of the great weight resting upon them. The cracks appear to be recent, and loose splinters of the marble can be detached.

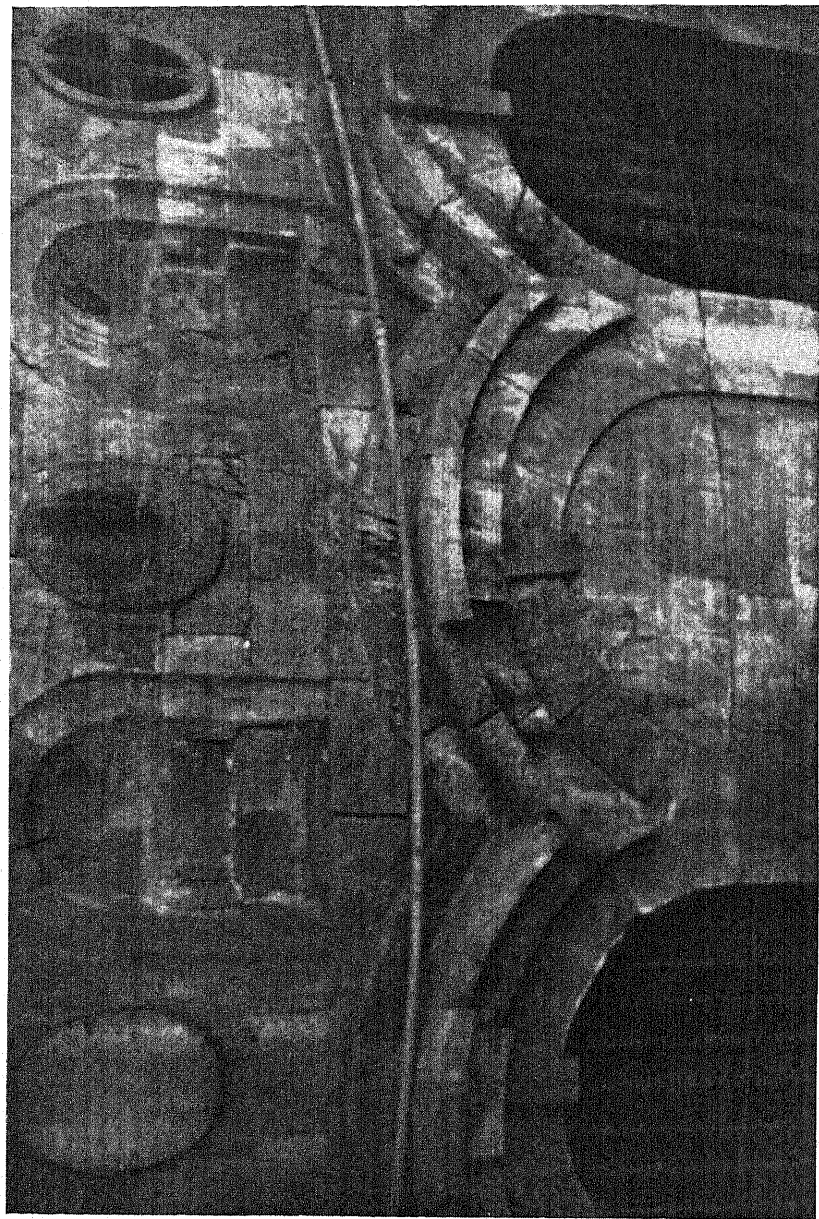
FIG. 18. APSE EXTERIOR

The Eastern arm of the Church dates from the twelfth century, but the work is obscured by the plastering and additions of 1810 (see Figs. 16, 17, I, 5-II, 2). The apse (see Figs. I, 6-II, 3) is divided into two stories, of which the lower probably retains a twelfth-century core, while the upper is completely of the 1810 rebuilding. While the lower work remains upright, owing to the buttressing effect of many low vaults entirely surrounding it, the upper work is in a bad state of disrepair (see Fig. 18).

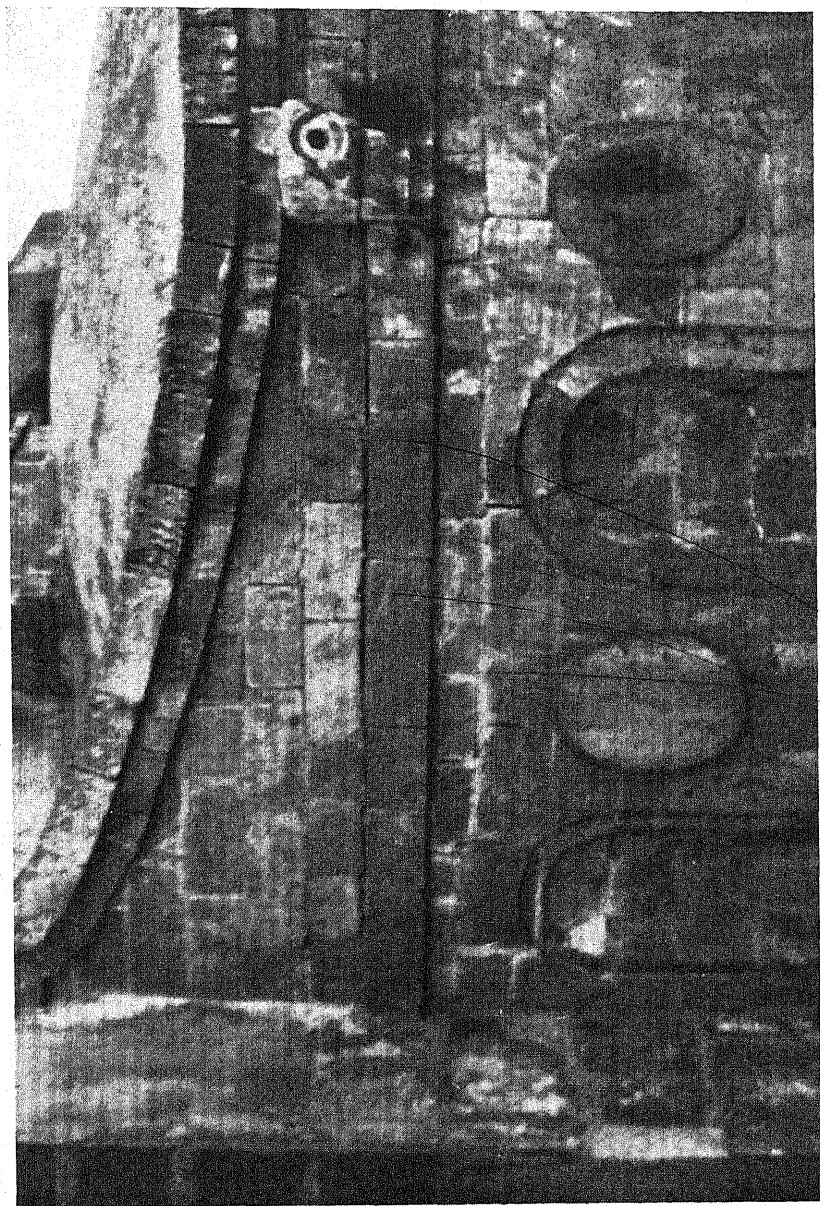
FIG. 19. APSE PARAPET

Near the apse roof, the bed-joints of several courses are devoid of mortar (see Fig. 19), and the parapet, unrestrained by any tie-bars, has moved outwards (see Fig. 20).

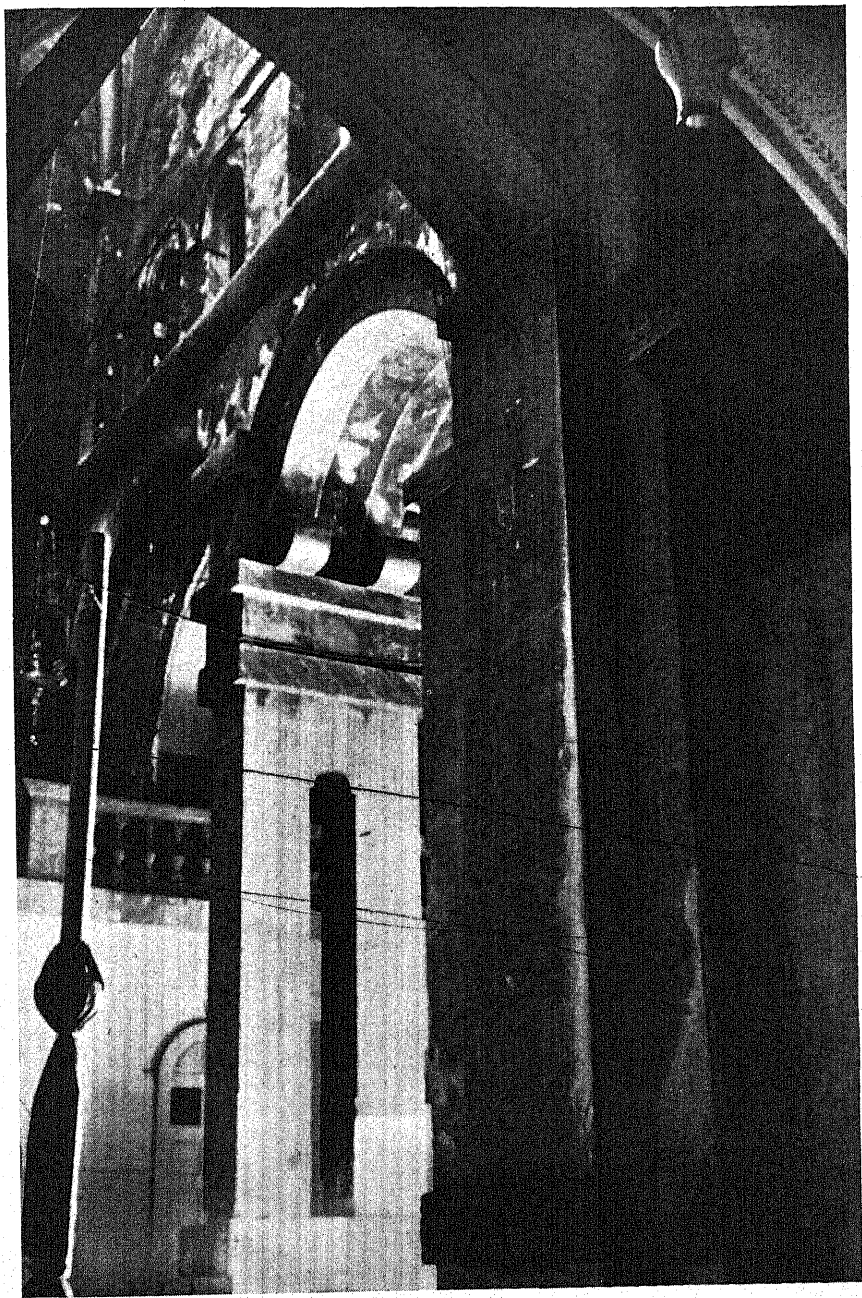
FIG. 21. SOUTH TRANSEPT FROM N.W.

The South Transept (see Figs. I, 1-II, 2), including the main front of the Church, contains much twelfth-century work; but the interior suffered greatly from the fire, and was partly rebuilt (see Figs. 21, 22, 23). The South wall shows very considerable calcining of the masonry, principally in the upper story, and a large proportion of the stonework is unfit to support the superincumbent weight and thrusts.

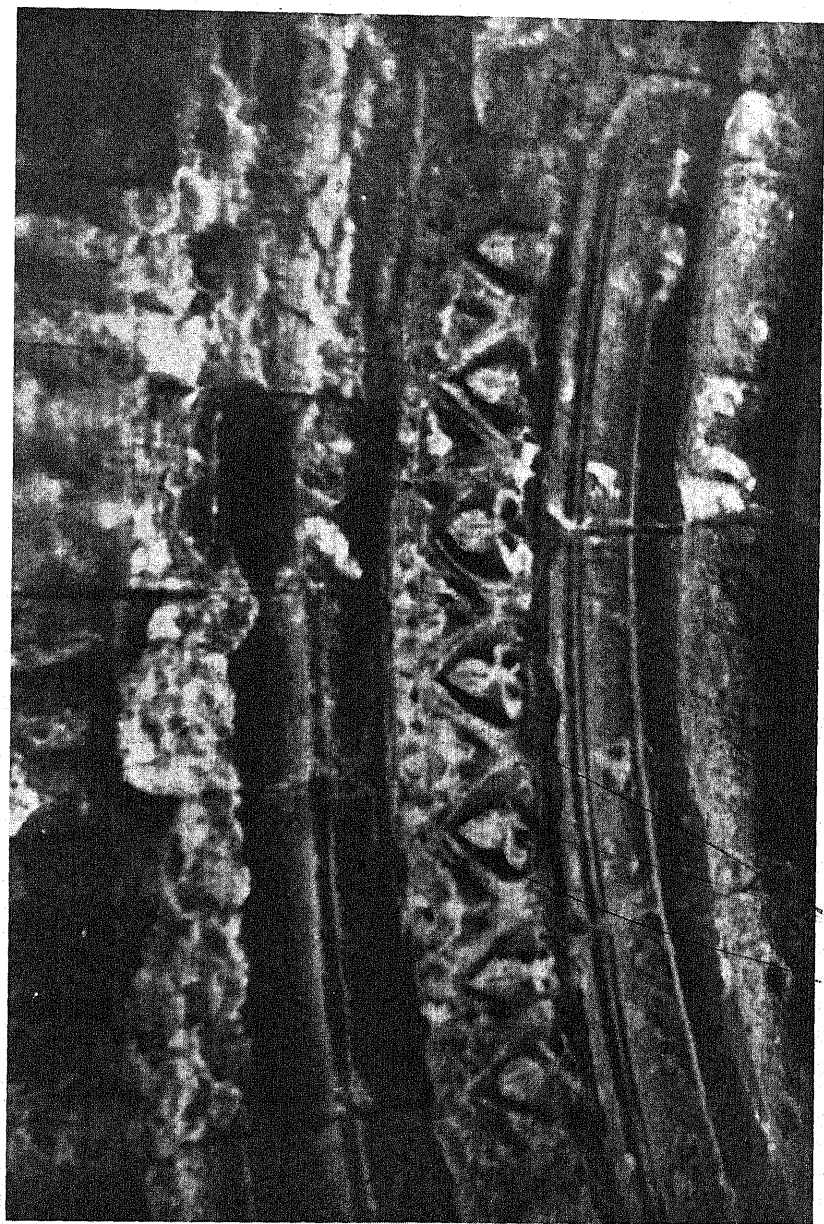
FIG. 31. PART OF CALCINED MOULDINGS TO UPPER ARCHES

The lower colonnettes and their bases are almost all cracked, the oblique direction of the cracks showing the asymmetrical loading of the arches above (see Fig. 24). The condition of most of the carved work is extremely good (see Figs. 25, 26, 27, 28, 29) with the exception of the inner orders of the upper arches, which suffered most from the fire (see Figs. 30, 31, 32).

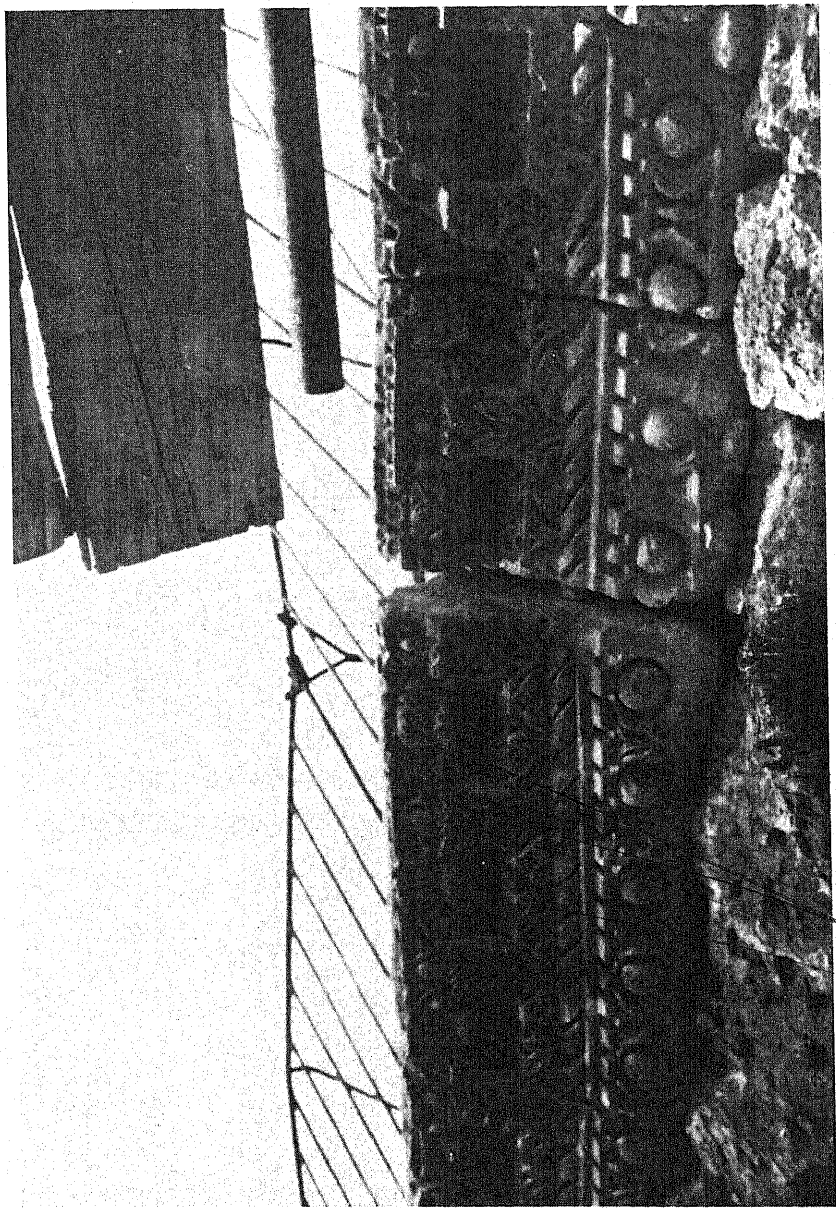
FIG. 33. DISLOCATED BLOCKS OF MAIN CORNICE

The main cornice at the wall top is greatly dislocated (see Figs. 33, 34) and harm has been done by the insertion of iron wedges and cramps which have caused cracking, due to rust (see Fig. 35).

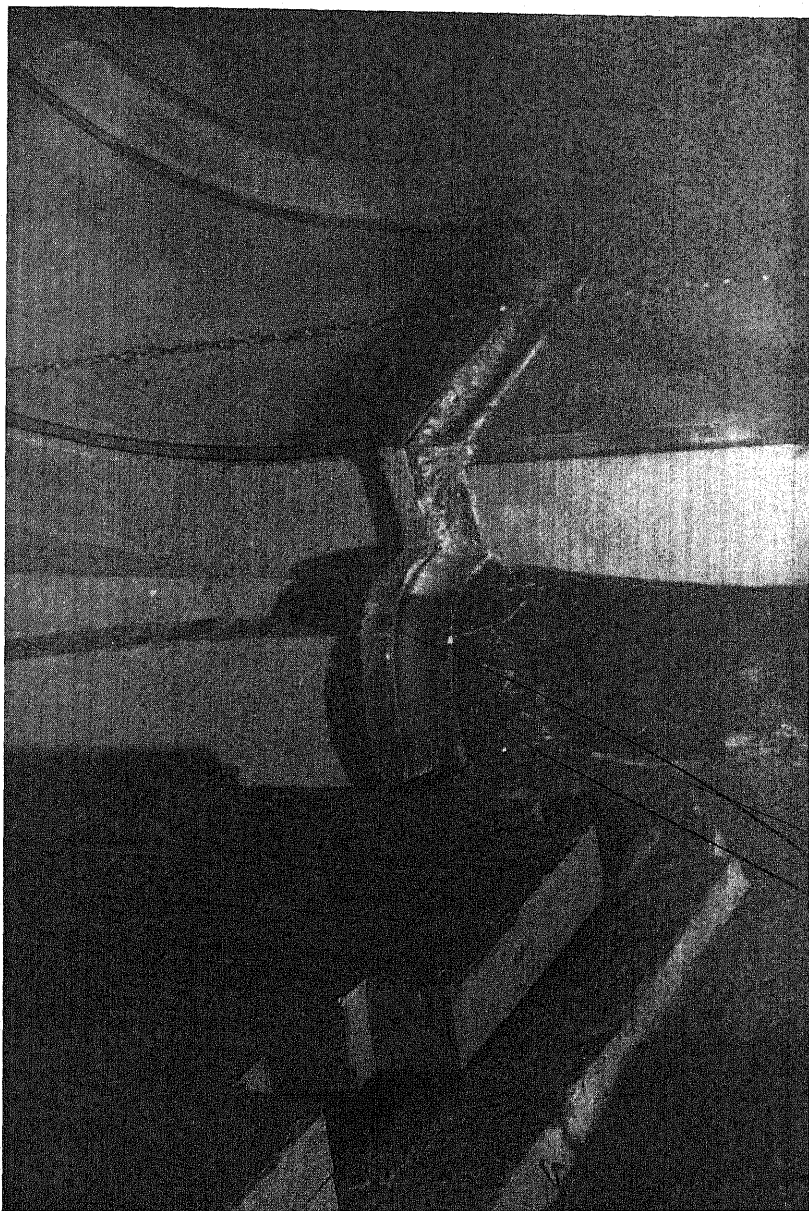
FIG. 42. CAPITAL DESTROYED BY 'RESTORATION' OF 1810. AMBULATORY

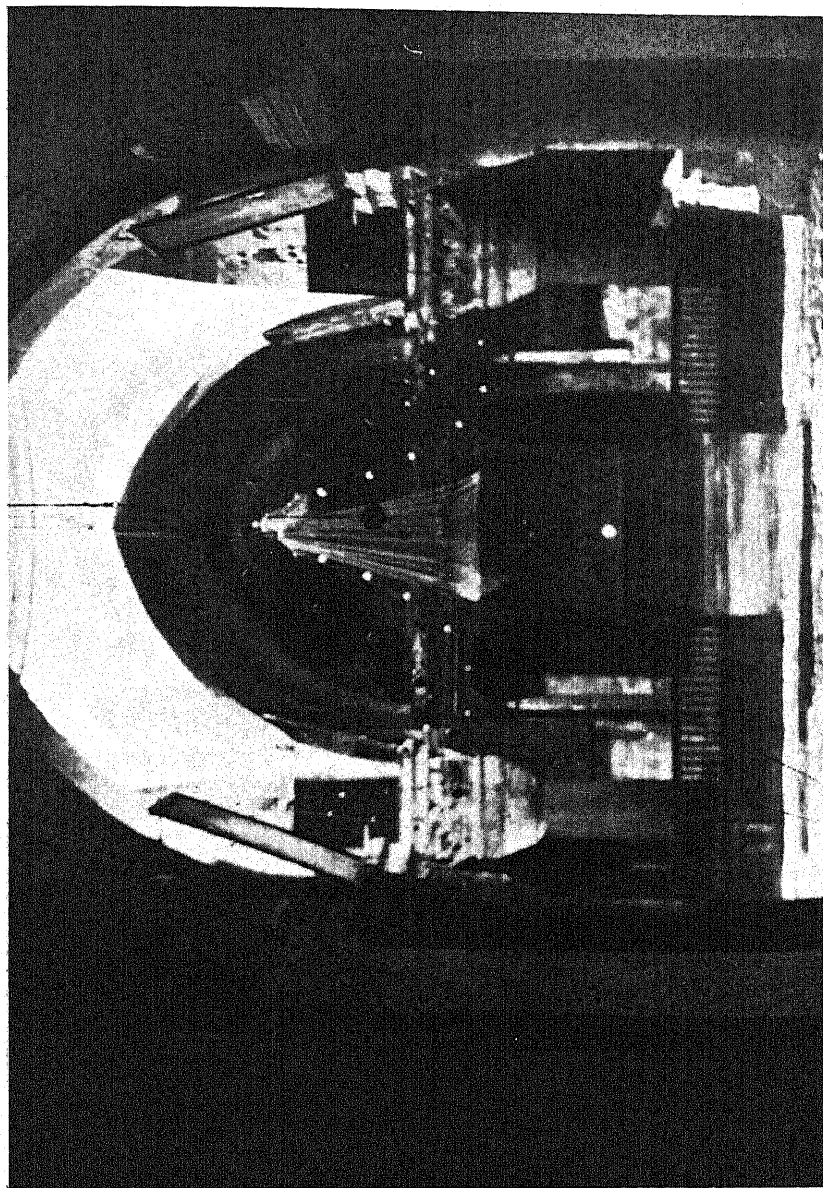
FIG. 44. ST. HELENA'S CHAPEL FROM W.

The Chapel of St. Helena (see Figs. 44, I, 28) lies below ground-level (see Fig. 45) and there is consequently but slight

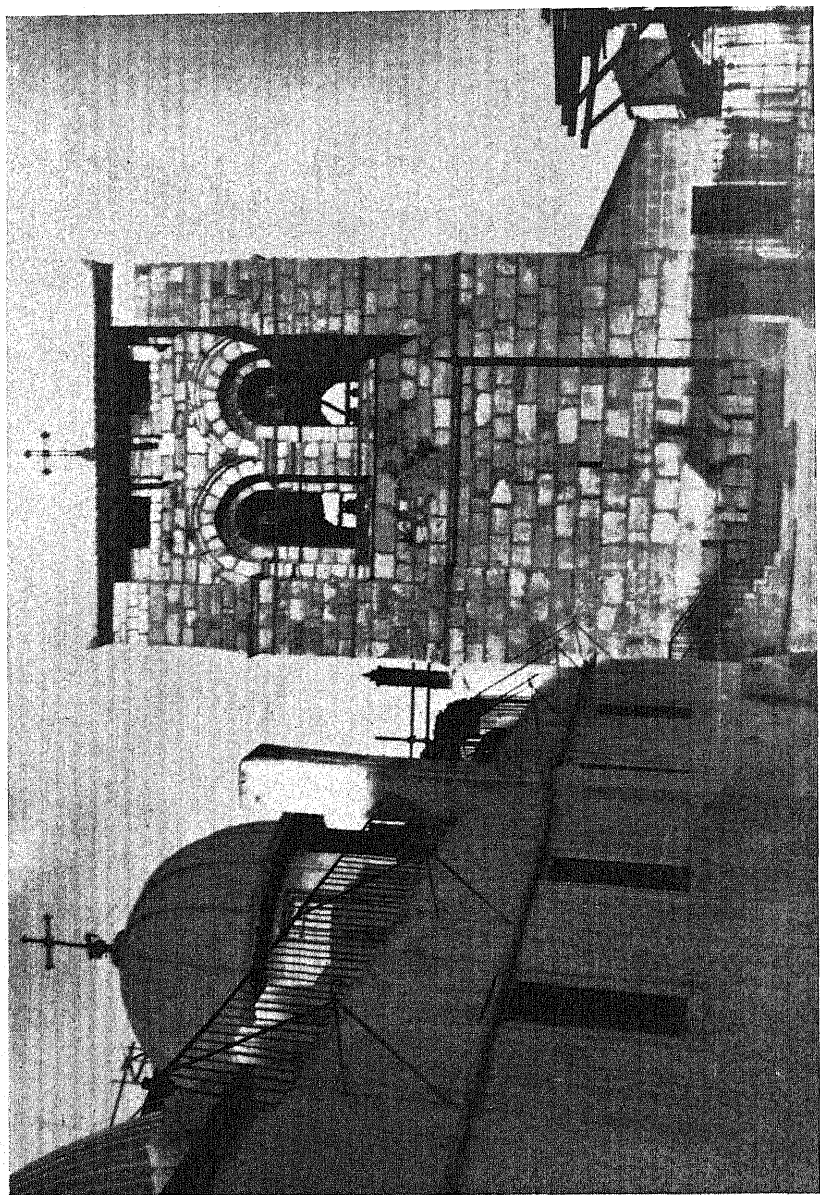
FIG. 57. TOWER FROM W. AND CHAPEL OF CONSTANTINE

At the top the outward inclination is severe, and has affected the surrounding vaults and further walls (see Fig. 57).

Almost at the top is the small Chapel of St. Constantine (see Fig. II, 21); it is within this that the outer Rotunda wall shows its worst leans, which are also easily perceptible in the opposite South wall of the Chapel, which stands on the Convent roof (see Fig. 57). The condition of both walls at this level is serious, as large cracks in the surface stucco of the Chapel show.

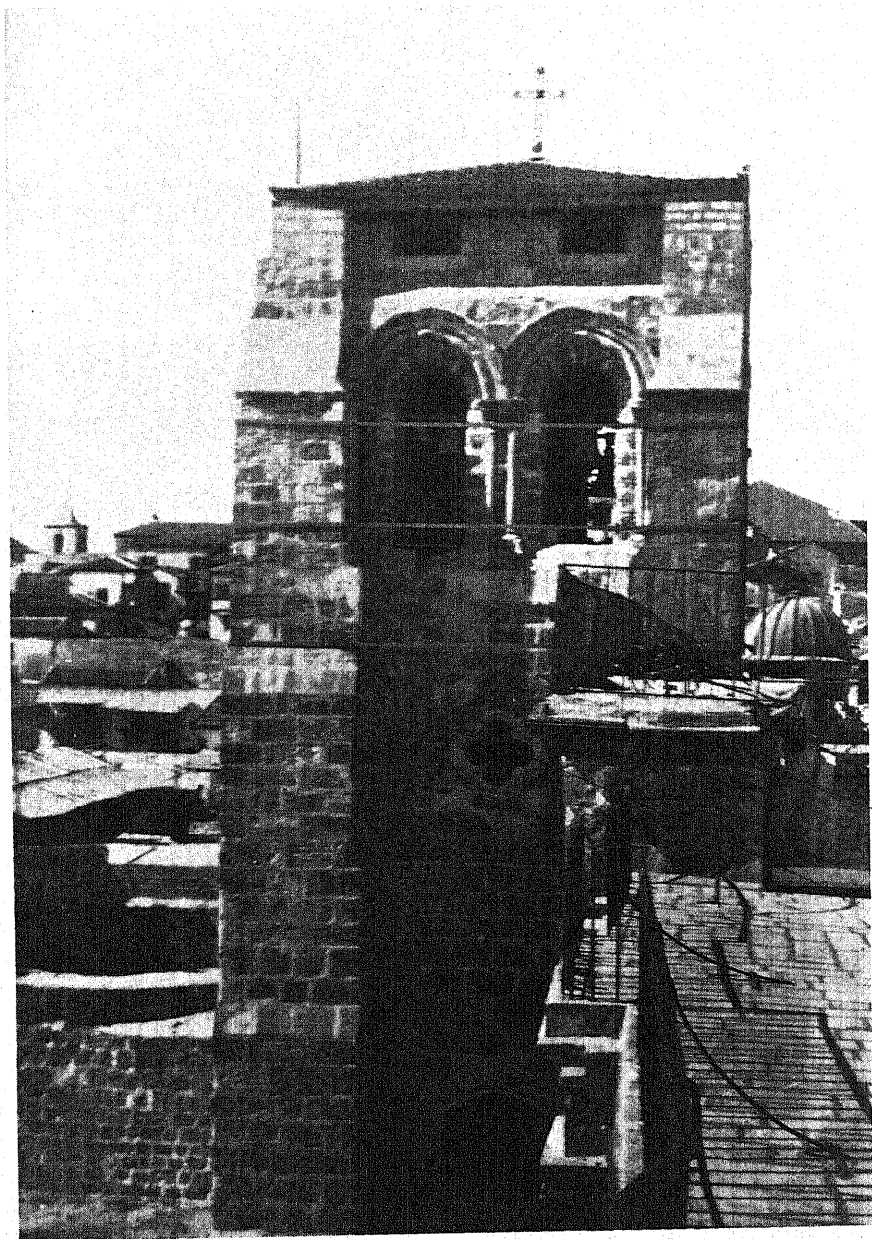
FIG. 58. TOWER FROM E.

Previously the roof had collapsed to the south in the earthquake of 1545, and carried with it the dome of the old Baptistery (see Fig. 58).

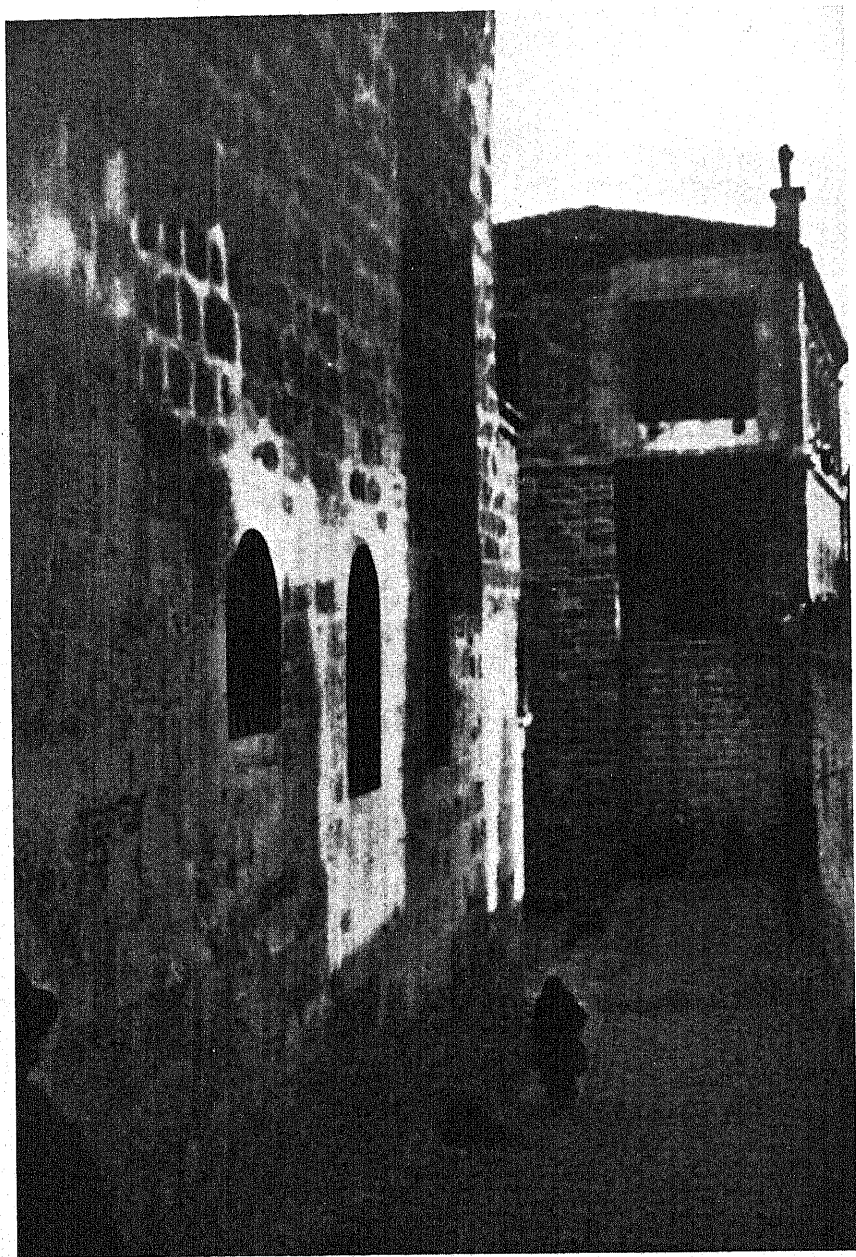
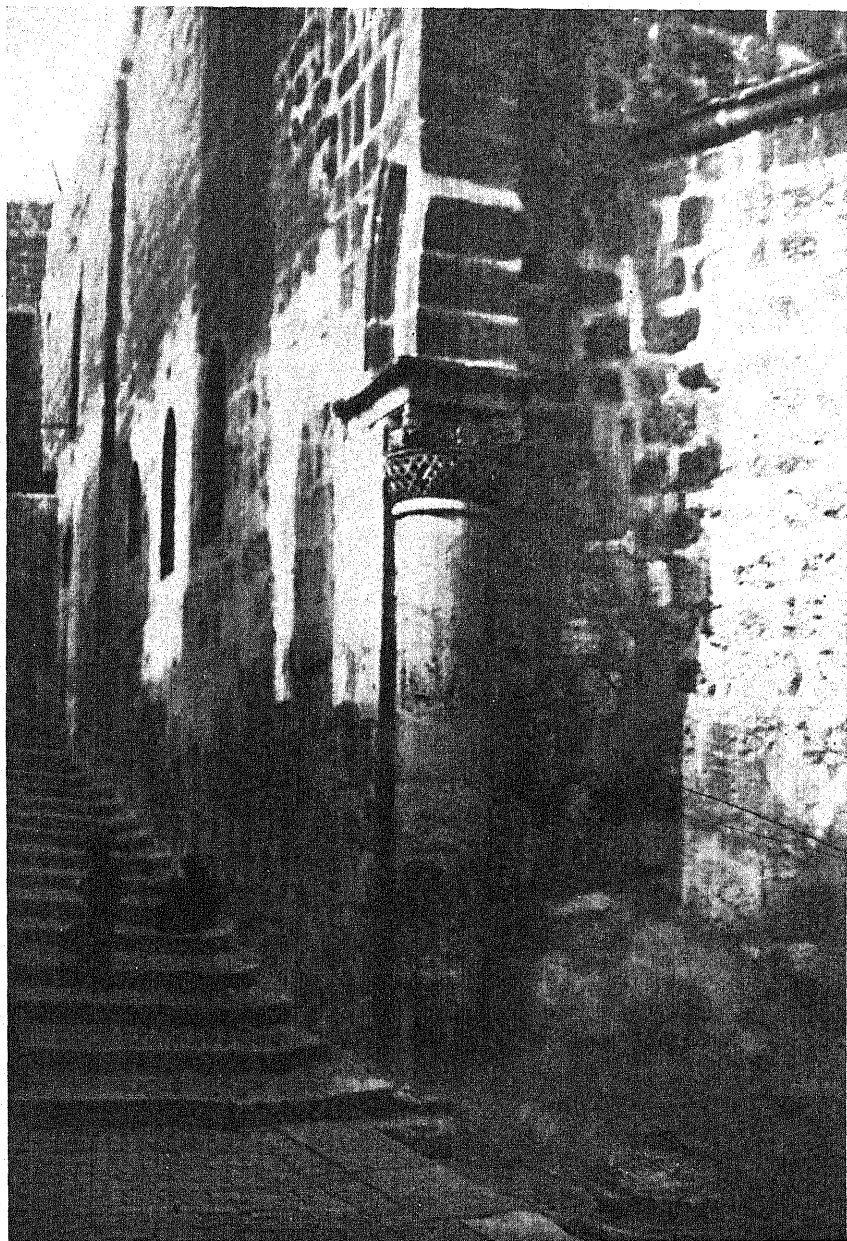
FIG. 61. SOUTH WALL OF CHAPEL OF ST. JAMES

This Chapel is in a state of grave danger, as the lower half of its South wall (see Figs. 61, 62) overhangs the adjoining street

by  $22\frac{1}{2}$  centimetres, and the crown of the vault is cracked throughout its length (see Figs. 63, V).

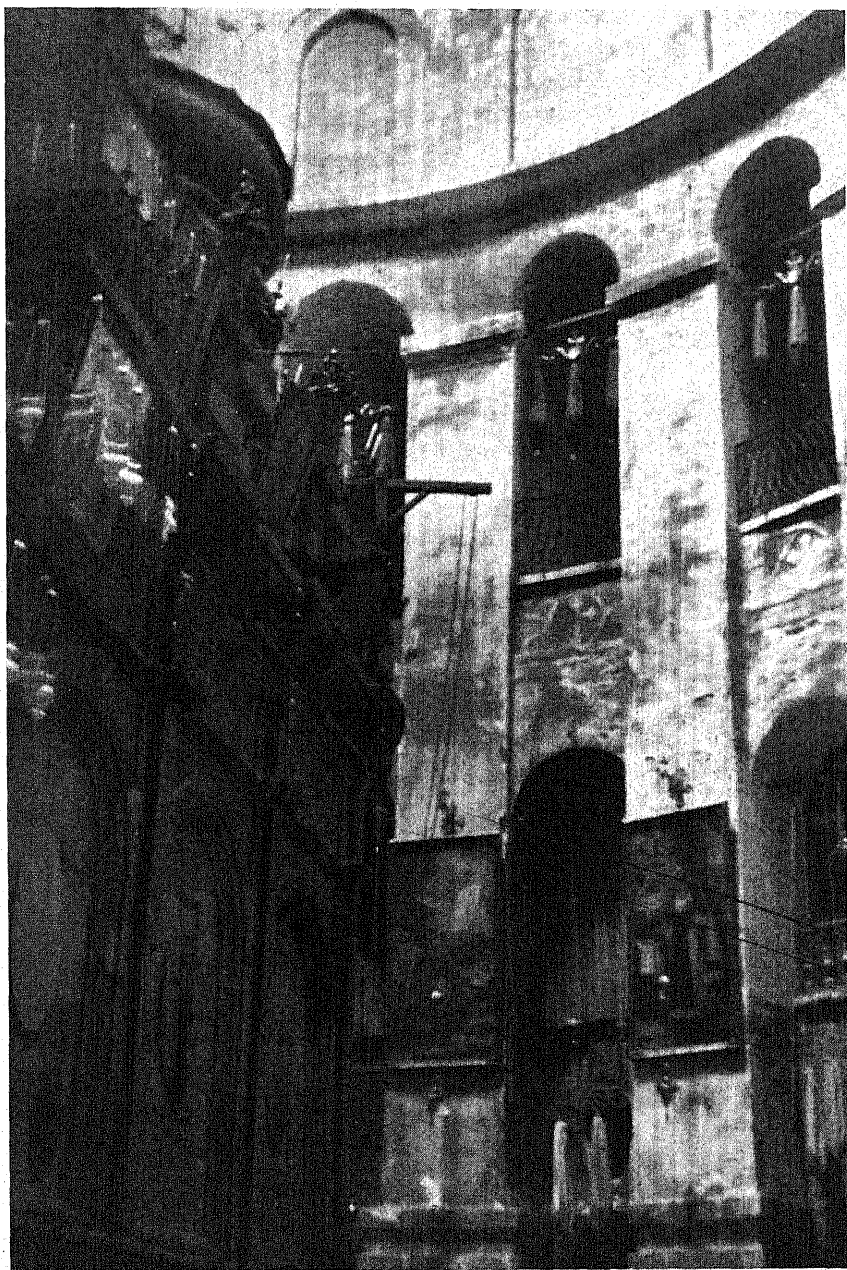
FIG. 64. NORTH-WEST PART OF ROTUNDA

The piers of the main Rotunda (see Fig. I, 13) are now square (see Fig. 64), though they probably enclose as a core the earlier round columns of the building of Constantine Monomach (c. A.D. 1048). The present piers are clamped together with rusting iron (see Fig. 65), are very irregular in shape and size, and are not placed symmetrically beneath the circular drum built in 1867. They are therefore subject to eccentric loading, and all of them show cracks to a greater or less extent; some of these cracks are serious, though certainly due to earthquake shock as well as to thrusts (see Fig. 66).

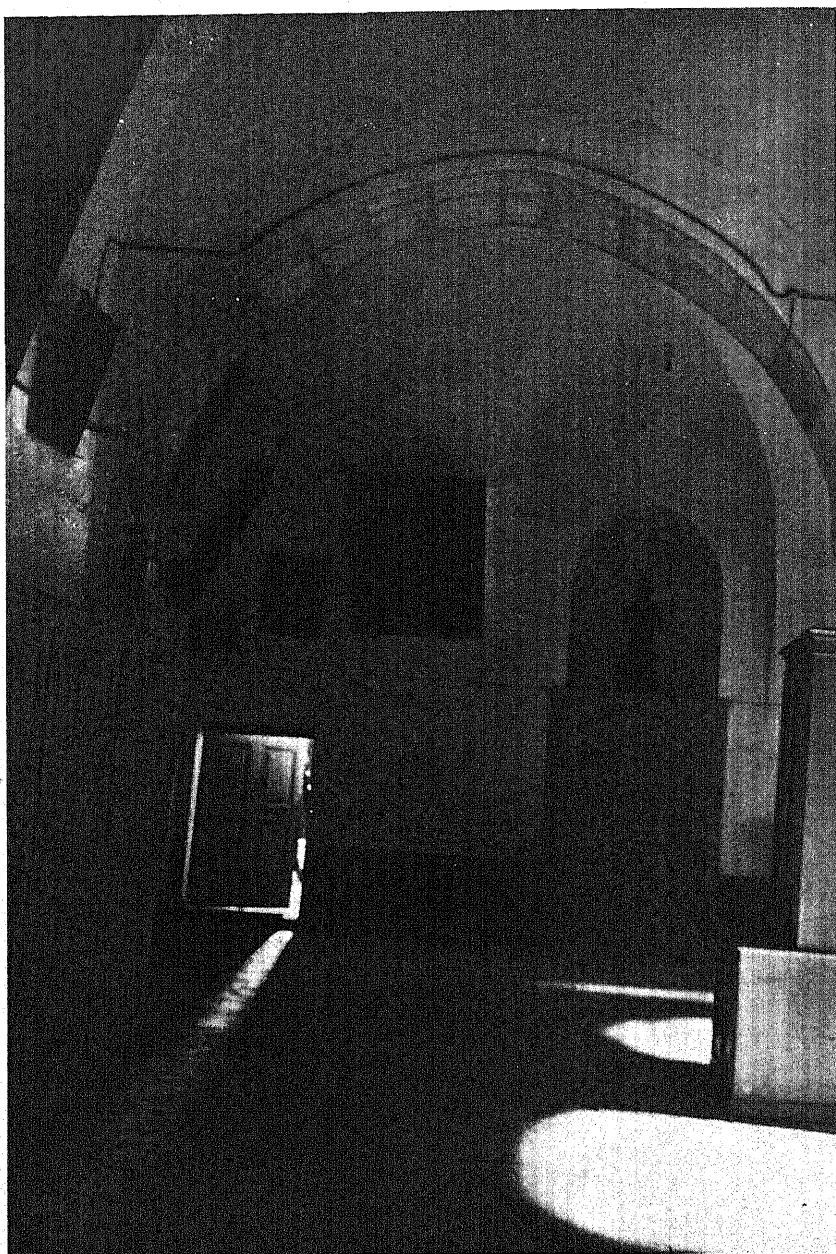
FIG. 67. FRANCISCAN UPPER GALLERY OF ROTUNDA

The galleries of the Rotunda (see Fig. 67) surround the main piers, and are enclosed by a circular wall, whose lower portions date from Constantine's original Anastasis (see Fig. 68). This circular wall leans outwards owing to the thrusts of the gallery vaults and the communicated thrusts of the cone which covered the central space prior to 1808.

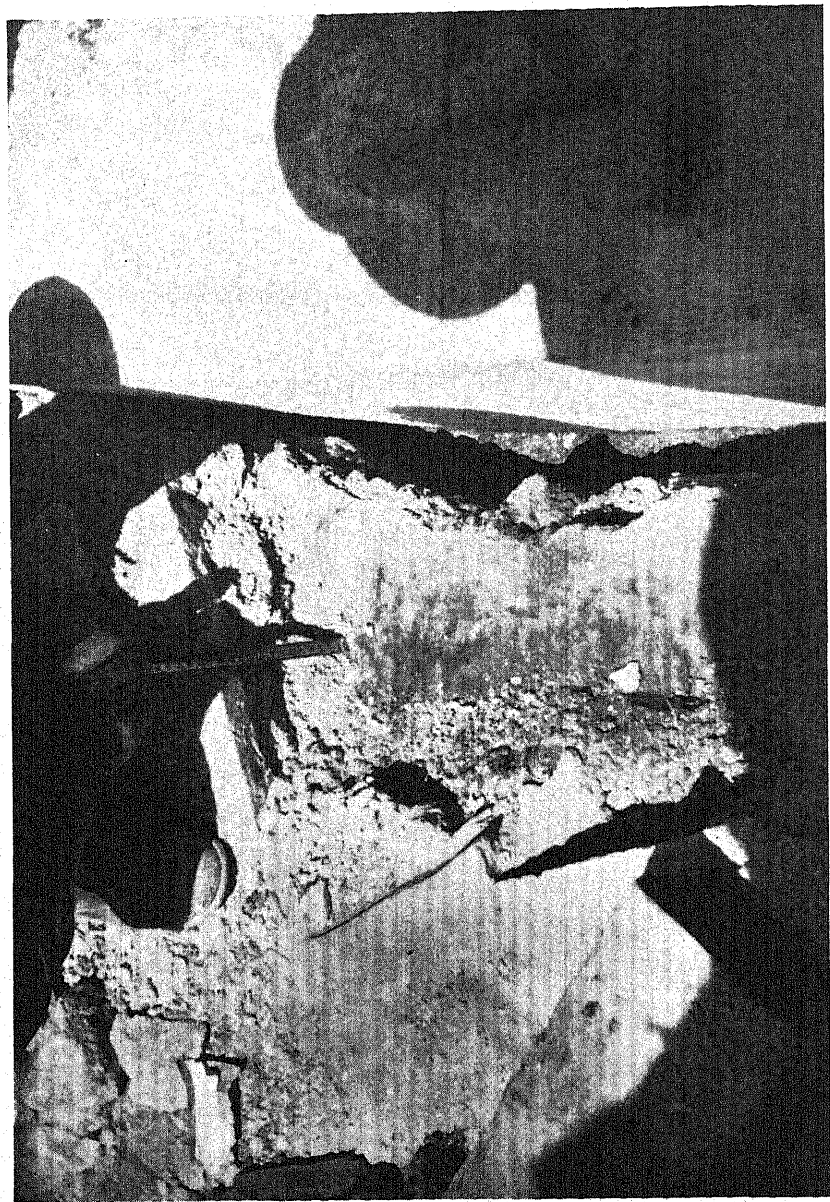
The roofs in general are in a bad state, and allow much rain-water to penetrate to the interior. As previously mentioned this has led to much extra weight being imposed on the building as successive layers of roofing material have been laid (see Fig. 69).

FIG. 69. PORTION OF HIGH VAULT ROOF, SHOWING SUPERIMPOSED  
LEVELS OF SLABS
